ANNUAL REPORT FOR 2015

Middle Fork Creek Site I Mitigation Site
Madison County
TIP No. R-2518A
COE Action ID: SAW-2007-2197-357/300
DWR #: 20071134

Prepared By:
Natural Environment Section & Roadside Environmental Unit
North Carolina Department of Transportation
November 2015

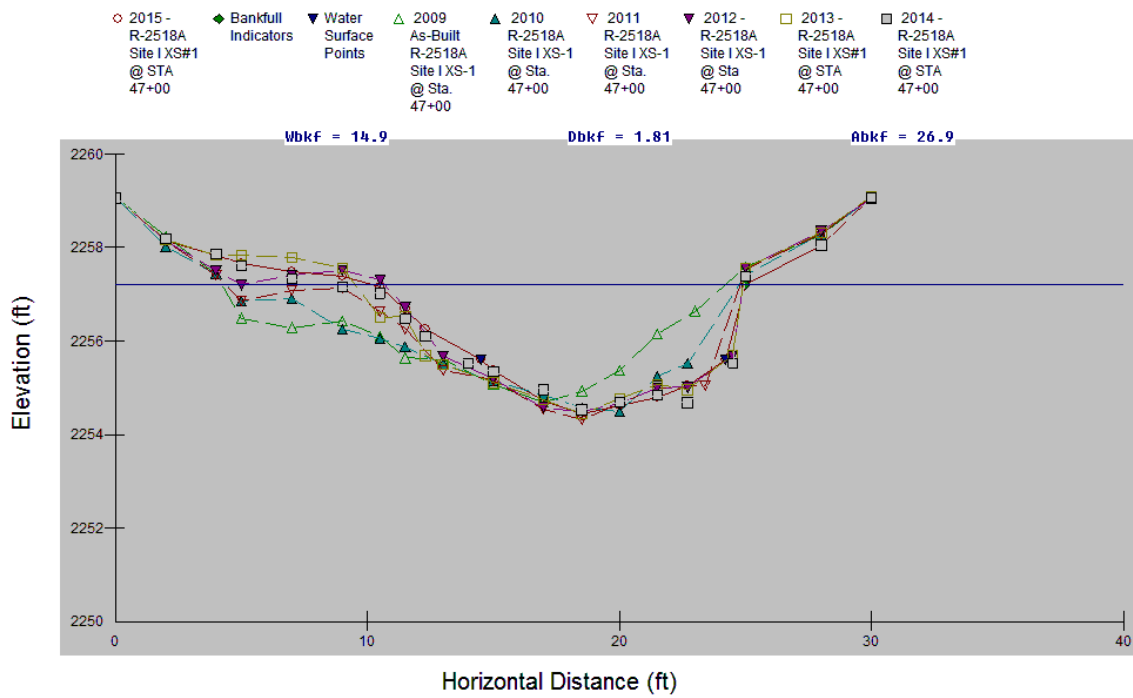
R-2518A Site I XS#1 @ STA 47+00

Site I: Cross-Section #1 (Pool) Abbreviated Morphological Summary						
	2010	2011	2012	2013	2014	2015
Bankfull Cross Sectional Area (ft ²)	34.89	42.04	33.97	34.54	31.17	26.95
Maximum Bankfull Depth (ft.)	2.93	2.89	3.07	3.11	2.86	2.78
Bankfull Mean Depth (ft.)	1.66	1.67	1.61	2.16	1.7	1.81
Bankfull Width (ft.)	20.97	25.14	21.16	15.99	18.36	14.89

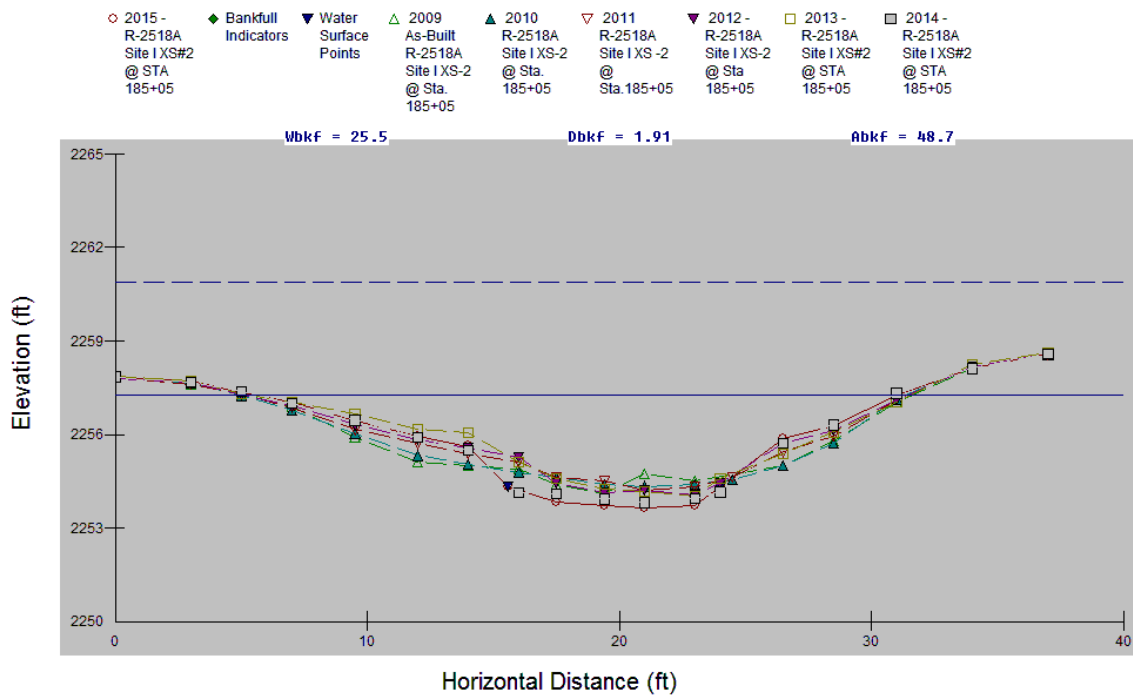
R-2518A Site I XS#2 @ STA 185+05

Site I: Cross-Section #2 (Riffle) Abbreviated Morphological Summary						
	2010	2011	2012	2013	2014	2015
Bankfull Cross Sectional Area (ft ²)	46.76	42.04	41.31	36.86	49.33	48.75
Maximum Bankfull Depth (ft.)	2.8	2.89	1.64	3.01	3.5	3.61
Width of the Floodprone Area (ft.)	37	37	37	37	37	37
Bankfull Mean Depth (ft.)	1.83	1.67	1.64	1.54	1.92	1.91
Width/Depth Ratio	13.96	15.05	15.35	15.58	13.38	13.36
Entrenchment Ratio	1.45	1.47	1.47	1.54	1.44	1.45
Bankfull Width (ft.)	25.54	25.14	25.17	24	25.68	25.52

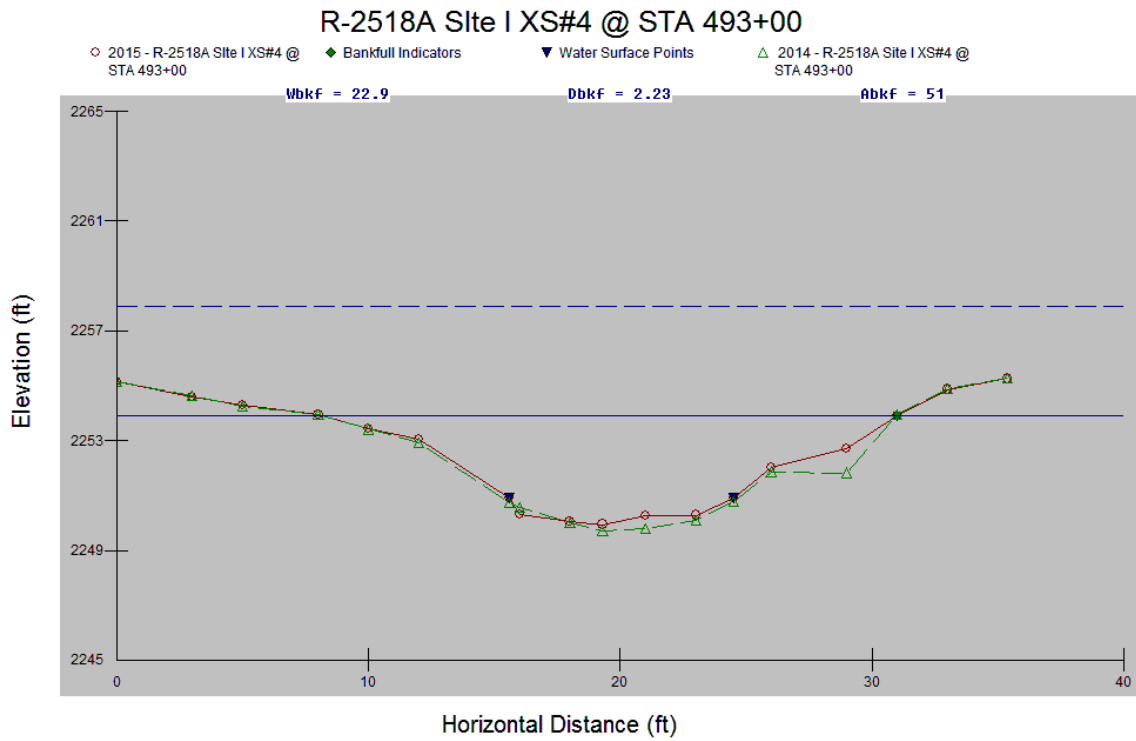
Site I: Cross-Section #4 (Riffle) Abbreviated Morphological Summary						
	2010	2011	2012	2013	2014	2015
Bankfull Cross Sectional Area (ft ²)	43.32	41.82	40.88	40.61	56.47	50.96
Maximum Bankfull Depth (ft.)	2.86	2.95	3.27	3.46	4.23	3.98
Width of the Floodprone Area (ft.)	35.4	35.4	35.4	35.4	35.4	35.4
Bankfull Mean Depth (ft.)	1.83	1.77	1.73	1.71	2.46	2.23
Width/Depth Ratio	12.9	13.35	13.62	13.89	9.35	10.26
Entrenchment Ratio	1.5	1.5	1.5	1.49	1.54	1.55
Bankfull Width (ft.)	23.61	23.63	23.57	23.75	23	22.88

*Cross Section #4 had to be reset after stream repairs were completed in June 2014, so therefore, the 2014 and 2015 monitoring data was not overlaid with the previous monitoring years.

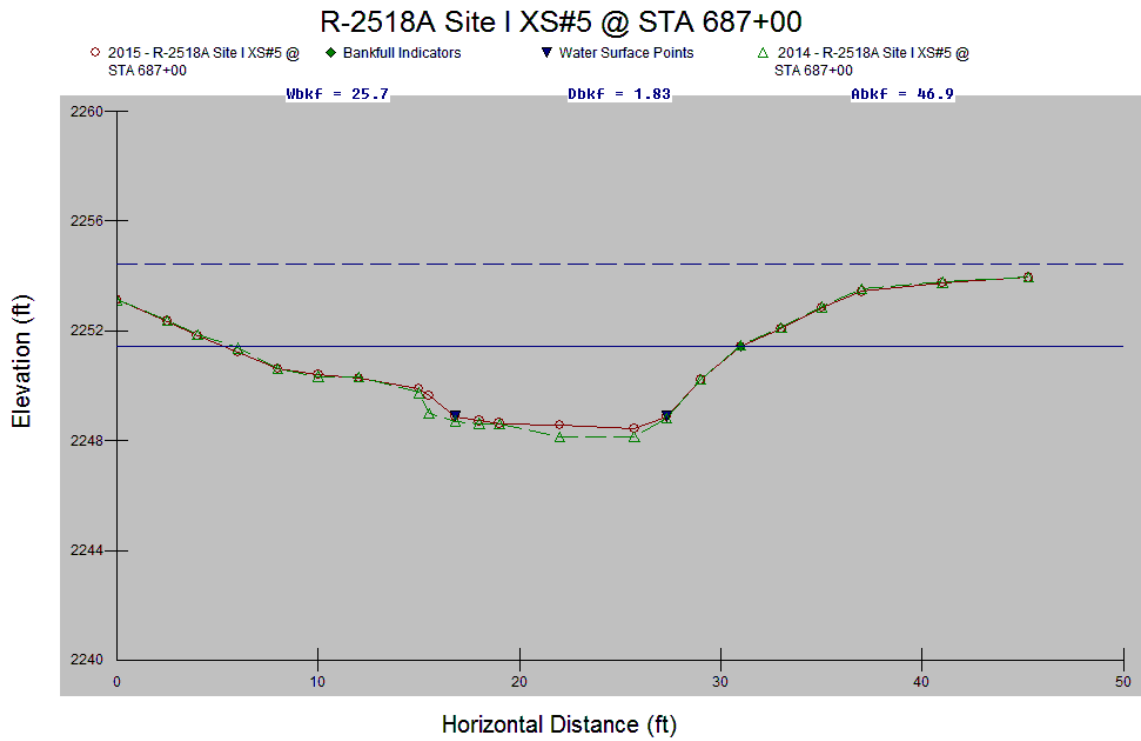
Site I: Cross-Section #5 (Riffle) Abbreviated Morphological Summary					
	2011	2012	2013	2014	2015
Bankfull Cross Sectional Area (ft ²)	52.26	46.77	49.35	51.08	46.92
Maximum Bankfull Depth (ft.)	2.89	2.78	2.99	3.33	3
Width of the Floodprone Area (ft.)	45.3	45.3	45.3	45.3	45.3
Bankfull Mean Depth (ft.)	2.04	1.87	1.96	2.01	1.83
Width/Depth Ratio	12.57	13.41	12.83	12.62	14.04
Entrenchment Ratio	1.77	1.81	1.8	1.79	1.76
Bankfull Width (ft.)	25.64	25.07	25.15	25.37	25.7

*Cross Section #5 had to be reset after stream repairs were completed in June 2014, so therefore, the 2014 and 2015 monitoring data was not overlaid with the previous monitoring years.
